DENON

Service Bulletin

No. : OST-F1108 **Date:** March 13, 2007

Model: AVR-2307CI, AVR-887

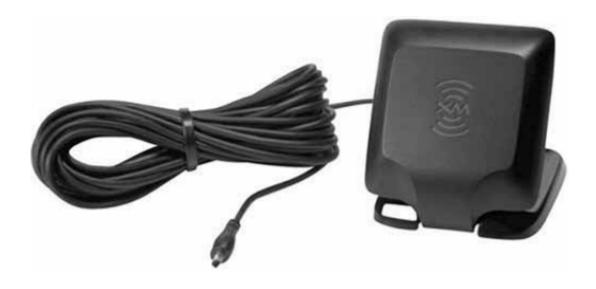
Detail of XM Antennas: XM Antenna CNP-1000 (old type XM Antenna)

Symptom: Sometimes equipment does not receive XM radio properly with the CNP-1000 type XM Antenna. Malfunction: no indication of the station name, no output and no channel selectable when using XM radio.

Solution: Please install the Exclusive Writer Software to a PC and rewrite your customer's unit upon claim of XM radio malfunction.
