PETERBILT TRUCKS

Troubleshooting Guide For Multiband Antenna System

Troubleshooting Part Numbers and Models verifying peterbilt truck model and multiband antenna system

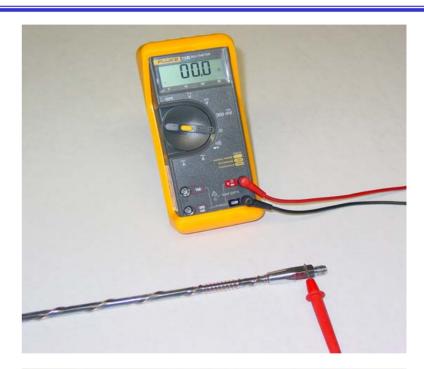
Verify that each whip antenna has a good connection/solder joint at the ferrule end of the antenna. Remove the antenna cap and make a small cut in the heat shrink if required to expose the wire. Do not allow the wire to come out of the slot and uncoil. Using an ohmmeter, check for dc continuity from the antenna ferrule to the tip of the coiled wire at the opposite end of the antenna. While checking for continuity, flex/twist the ferrule end to check for intermittent breaks at the solder joint.

NOTE: The wire is coated with an insulating material. Before performing a continuity check, lightly sand the coiled wire end to expose a small "uncoated" portion near the tip of the antenna.

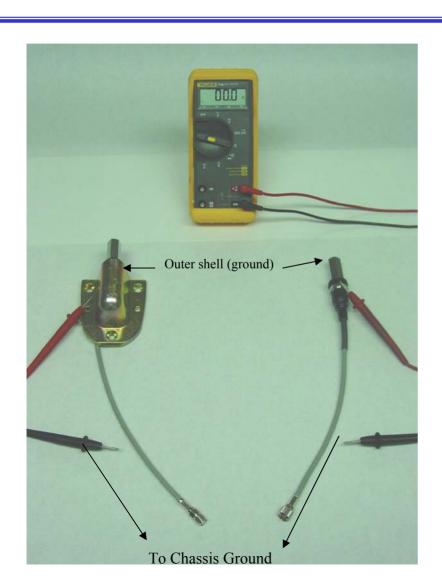
Bracket To Chassis Ground - 387 and All Other Models

With the cables disconnected at the kick panels on a 387 or disconnected at the multiplexer box on all other models Verify that the bracket assembly outer shell (ground) has dc continuity to chassis ground (less than 5 ohms). Test both sides.

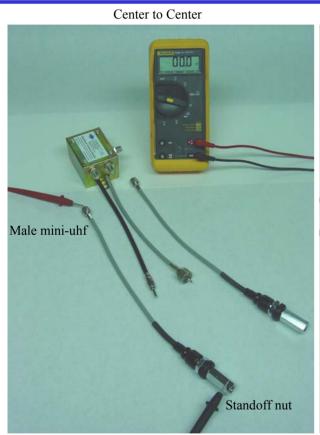
With cables disconnected from the multiplexer box Test from the center pin of the male mini-uhf connector to the standoff nut – dc continuity (test both sides)

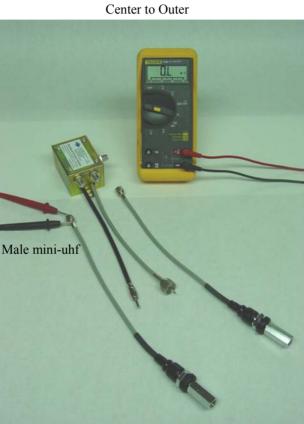
With cables disconnected from the multiplexer box Test from the center pin of the male mini-uhf connector to the outer shell of the male mini-uhf connector – no dc continuity (test both sides)

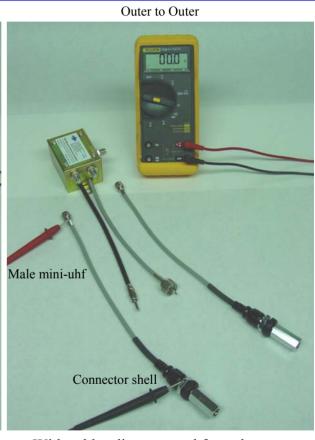
With cables disconnected from the multiplexer box Test from the outer shell of the male mini-uhf connector to the connector shell (ground portion) of the bracket mount – dc continuity (test both sides)

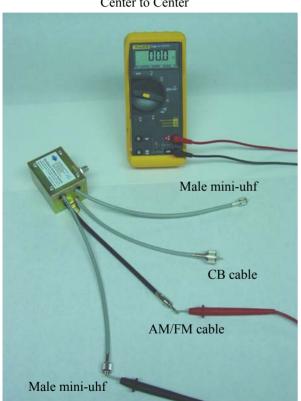
With cables disconnected at the kick panels Test from the AM/FM cable center conductor to the center pin of the male mini-uhf connector – dc continuity (test both sides)

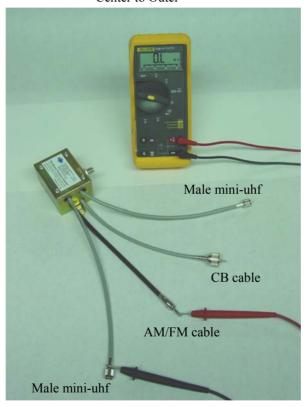
Center to Outer

With cables disconnected at the kick panels Test from the AM/FM cable center conductor to the outer shell of the male mini-uhf connector – no dc continuity (test both sides)

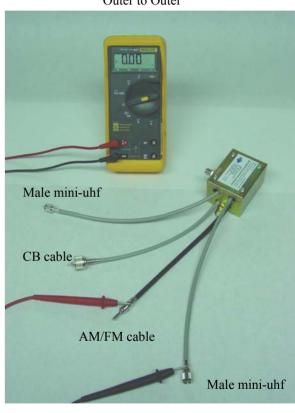
Outer to Outer

With cables disconnected at the kick panels Test from the outer shell of the AM/FM cable connector to the outer shell of the male mini-uhf connector – dc continuity (test both sides)

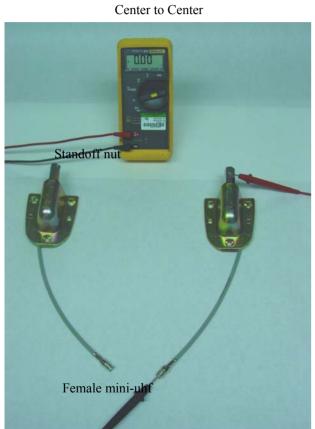
Center to Outer

With cables disconnected at the kick panels Test from the center pin of the female mini-uhf connector to the standoff nut – dc continuity (test both bracket assemblies)

With cables disconnected at the kick panels Test from the outer shell of the female mini-uhf connector to the standoff nut – no dc continuity (test both bracket assemblies)

With cables disconnected at the kick panels Test from the outer shell of the female mini-uhf connector of one bracket to the outer shell of the female mini-uhf connector of the second bracket – dc continuity
