## AR-3 Crossover Schematics

During its production cycle, AR modified the AR-3 crossover schematic several times. This note attempts to catalog those changes based on detailed information available in Tom Tyson's files. At some point a complete description of the AR-3 will be written [TT]; at that time this should become an appendix within that document.

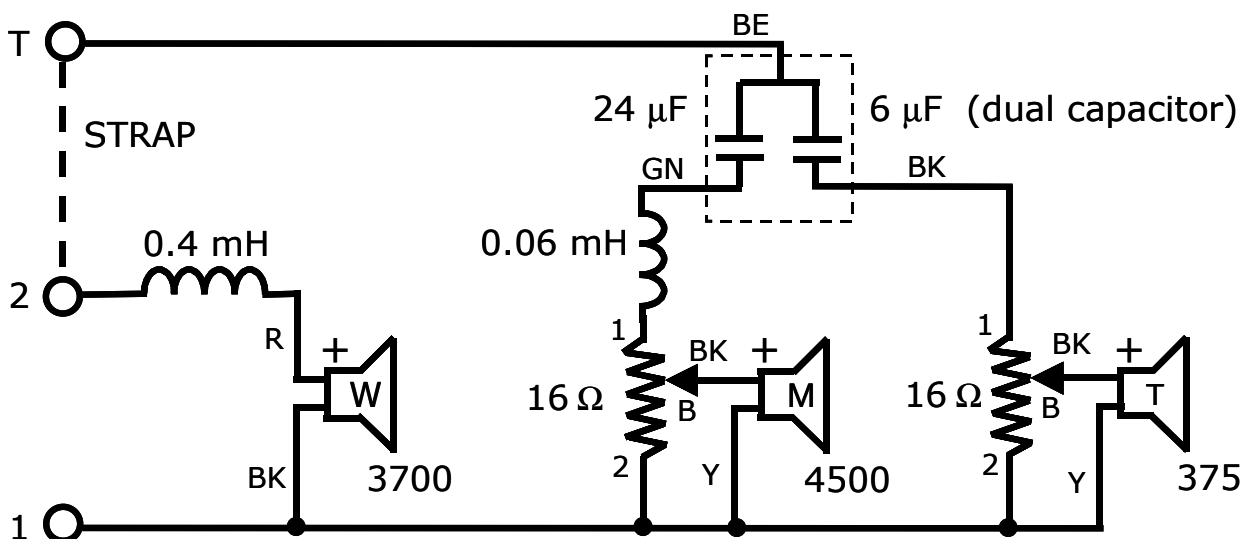
### A. Initial production through serial number C1413:

The schematic shown here; dated 13 March 1959 and initialed by EMV, is the original AR-3.

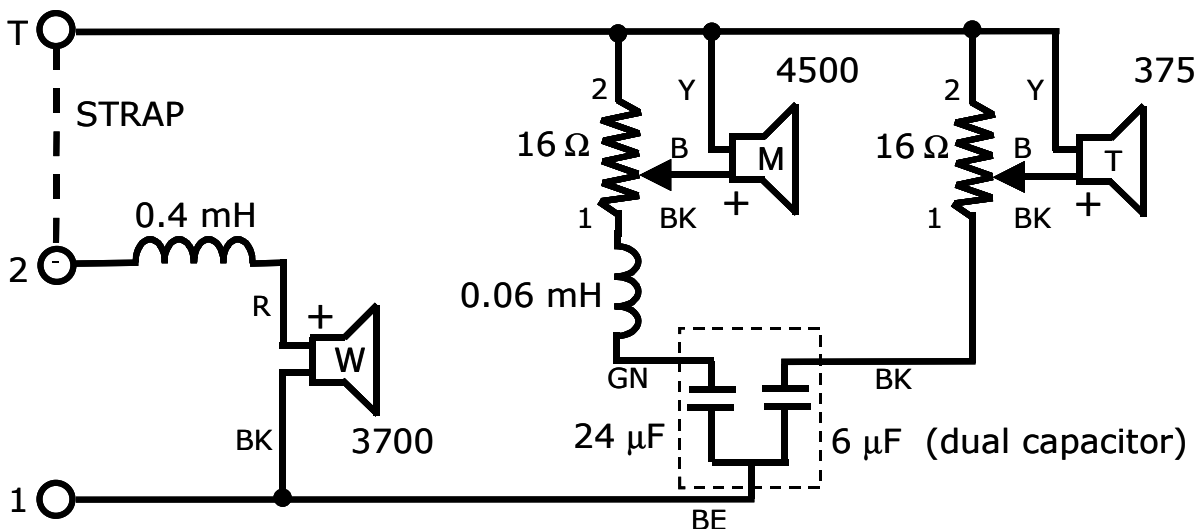
### B. Serial numbers C1414 – C19467:

In 1960 the crossover was changed to reverse the phase of the mid-range and tweeter with respect to the woofer [1]. This was the only change made at this point in production.

[1] Phase reversal was initially done manually by reversing the midrange/tweeter wiring with respect to the woofer. At some point, AR either reversed magnet polarization or internal coil wiring to change this phase internally. It is a daunting task to determine whether or not a particular AR-3 is in-phase or out-of-phase. The acoustically measured effect is only *slightly* noticeable and only barely audible—*not* to a great extent. Quite frankly, room-acoustic artifacts can have a much greater influence on the output of the AR-3 than the simple dc phasing reversal. If your AR-3 has never been opened or modified or repaired, it is almost assured that the dc phasing is correct for that speaker, so do not worry about attempting to change it. On the other hand, if a replacement driver of unknown pedigree was installed, then all bets are off. In order to determine exactly the phase relationship, the speaker must be electrically measured with a sine-wave oscillator and oscilloscope or with response measurements at the crossover frequencies, but this is quite difficult to determine accurately without professional test equipment. In the end, it's probably best not to worry about the phasing. If the speaker sounds too bright around the midrange crossover frequency (around 1000 Hz), and it is noticeable, you may reverse the lead-in wires from the midrange driver to the terminal strip (thus reversing the polarity of the midrange driver on the tweeter terminal strip on the front speaker baffle board under the grill). Since nearly all AR-3s used aluminum wire from the tweeters, soldering the aluminum lead-in pigtails requires AlumiSol aluminum solder to properly bond, so care must be used when unsoldering and re-soldering to insure a proper solder joint. An alternative technique for joining aluminum to copper by a crimp connection is described in the AR restoration document.

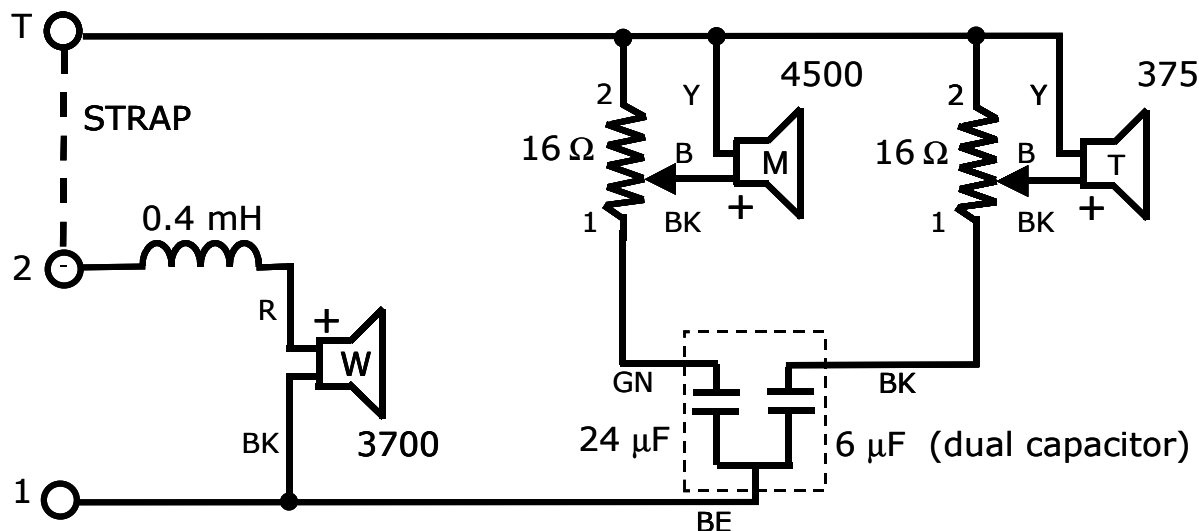
## C. Serial numbers C19468 – C70228:

The crossover was modified on 25 Aug. 1965 by removing the 0.06-mH (51-turn) coil in the mid-range crossover.

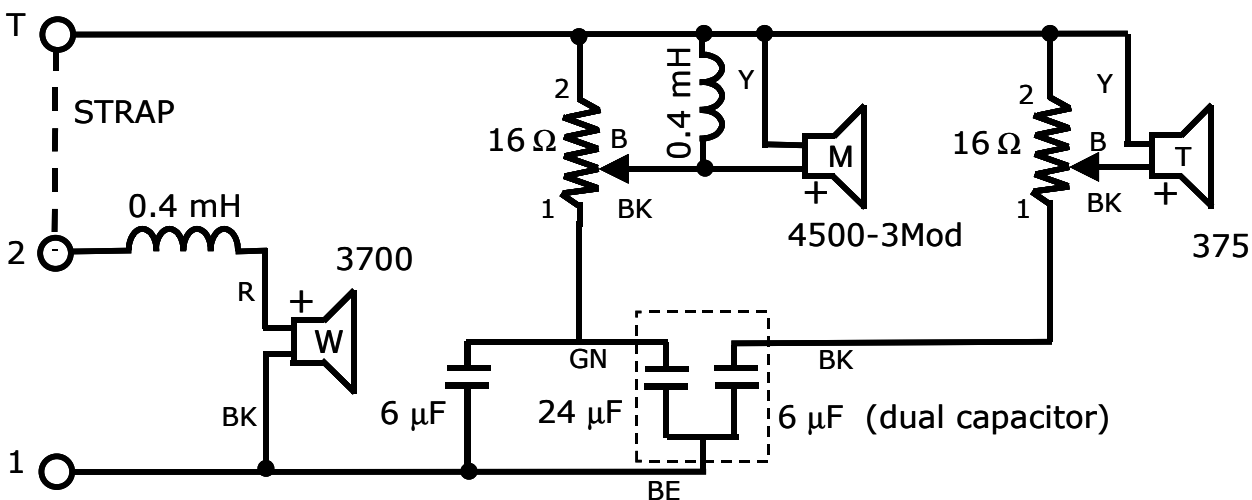
## D. Serial numbers C70229 to end of production:

On 13 May 1970, AR ran out of the original phenolic-dome mid-range. This required the use of a version of the AR-3a mid-range identified by part number 4500-3MOD and later identified as part number 200010-AR-3 or 200019-3. (These are Fig's. A.9 and A.10, respectively, in *Restoring the AR-3a*.) This required a crossover change, as the AR-3 and AR-3a did not have the same woofer-mid-range crossover frequency. This crossover change consisted of the addition of a 6-μF capacitor in parallel with the 24-μF (to make a total of 30 μF) and the addition of a 0.4-mH (143-turn) coil across the mid-range driver. These changes are illustrated below.

After the original mid-range supplies were exhausted, the new driver described in Section D was used for both production and service replacement. *So it is possible that an Internet-purchased speaker contains a service replacement mid-range.* Service replacement was not straightforward, as the crossover had to be changed to that shown in Section D. Thus, speakers with serial numbers of C19467 and lower needed to have their 51-turn coil removed before the parts for the new service replacement were added. Speakers with serial numbers greater than C70228 would not have needed the crossover modification, since the new style mid-range was installed when originally assembled.

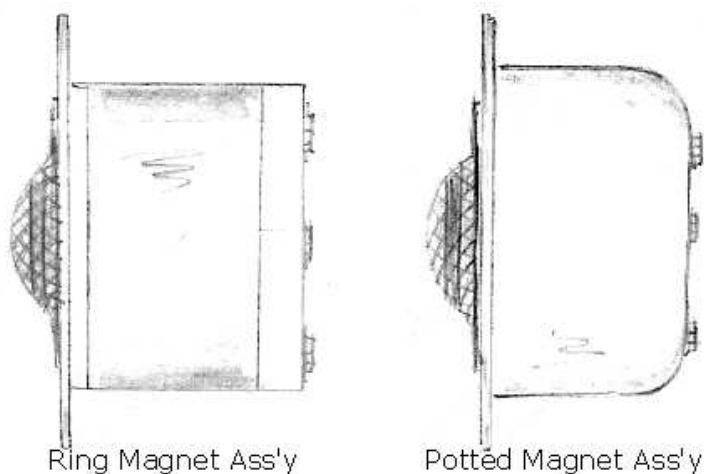
### G. Mid-range Magnet Structure:

At some point in the 30,xxx serial number range, AR changed the magnet structure from the modified form of the AR-1W, to a potted type magnet. The two cross-sectional views are shown here. These two styles are equivalent.
