*Phase Linear*  
*700*  
*700 B*

**SERVICE MANUAL**

700/700B  
SERVICE MANUAL

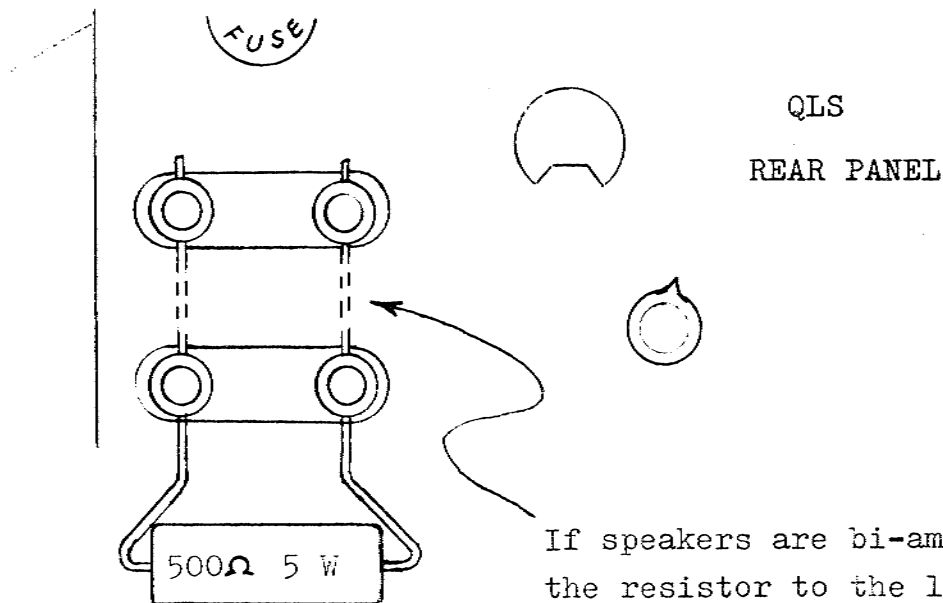
Recent field reports have shown an abnormally high failure rate on various power amplifiers coupled with any of the Infinity Quantum Line Source Speakers, among these the Phase Linear Model 400 and 700(B) amplifiers. After obtaining a set of QLS speakers here at the factory, our tests revealed that the 3000 mfd coupling capacitors in these speakers created a potentially hazardous condition to the power amp when switching the power off and then back on again before these large capacitors have fully discharged. We have discussed our findings with Infinity who has officially authorized our proposed modification which will eliminate the interface problem.

BEFORE OPERATING OR CONTINUING TO OPERATE ANY OF THE QLS SPEAKERS WITH PHASE LINEAR OR OTHER AMPLIFIERS, IT IS RECOMMENDED THAT AN APPROXIMATELY 500 OHM 5 WATT RESISTOR BE INSTALLED ACROSS THE TERMINALS OF EACH SPEAKER AS SHOWN IN THE DIAGRAM BELOW.

If speakers are bi-amped, connect the resistor to the low frequency input only.

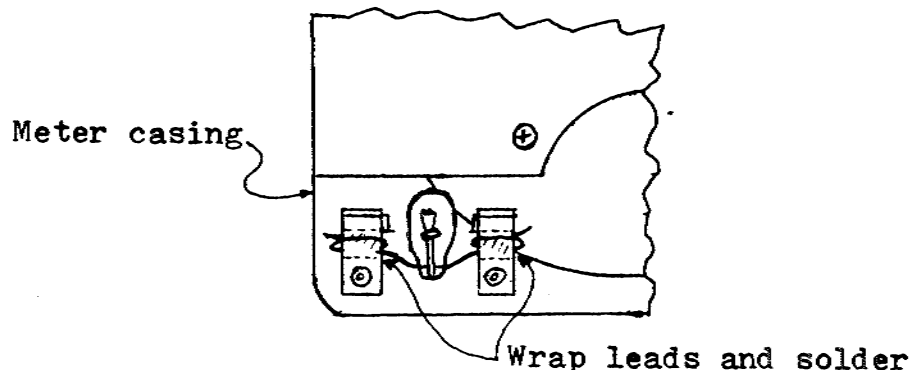
Unfortunately we have been unable to obtain any replacement lamps from the manufacturer. If you encounter a unit in which one or more of these lamps is burnt out, use the following procedure to restore proper meter lighting.

- 1) Remove all four of the fuse-type lamps from the meters
- 2) Obtain four #1784 meter lamps, supplied with the repair kits or obtainable from the factory on request.
- 3) Wrap and solder the leads of the #1784 lamps to the meter clips as shown in the diagram below.

Be sure to replace all four of the fuse-type lamps, for the #1784 lamps are significantly brighter.
